A new decade for social changes

Analysis of Disaster Safe School Level in West Coast of Pandeglang Regency, Indonesia

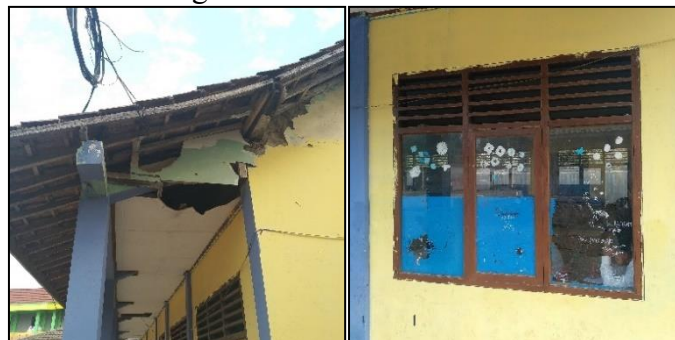
MTs Masyariqul Anwar also still needs to pay special attention to improve the resilience of school facilities. The results showed that MTs Masyariqul Anwar had not done a complete renovation of the building in the last 50 years. Observation results showed that the school roofs and ceilings were damaged and the walls were cracked. In classrooms design and arrangement, MTs Masyariqul Anwar has not yet implemented the design of the door that opens to outside. This will certainly complicate the evacuation process because victims of disasters including children will tend to feel panicked when a disaster occurs. This is also not in accordance with the Safe School Guidelines which recommends that the door must be open to outside. Besides that, there are also many windows that do not use trellises, and unfastened bookshelves and furnishings that easily fall during an earthquake. All of this makes the risk of casualties and losses due to disasters even higher.

Fig. 2 Building condition of MTs Masyariqul Anwar: broken ceilings (top) and windows without trellises (bottom)

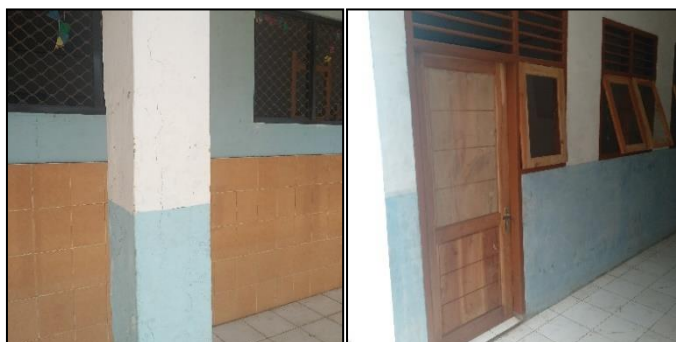
Fig 3. Building condition of SDN Mekarjaya 3: cracked column (top) and doors are still open inside (bottom)

Regarding the structure of the building, SDN Mekarjaya 3 received renovation assistance from a post-tsunami NGO in the form of repairing damaged buildings and facilities and constructing a new building consisting of three classes. However, the assistance provided has not yet refer to the Safe School Guidelines. This is found in the design of classroom doors and teacher rooms that are still open inside. So that renovation and construction of new school buildings does not necessarily reduce the existing risks. In terms of infrastructure, SDN Mekarjaya 3 still needs a lot of improvement, such as the need for fire estinguisher procurement and evacuation signs to the gathering point.

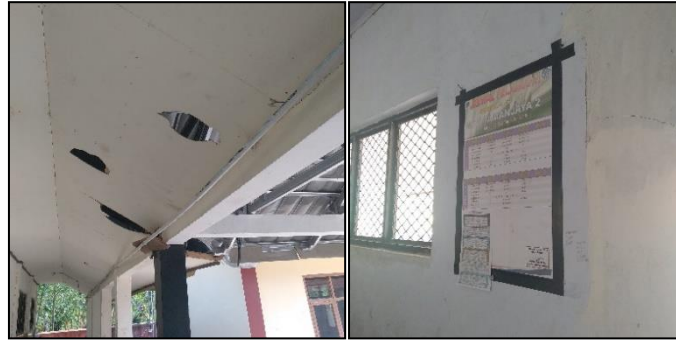
Fig. 4. Building condition of SDN Tamanjaya 2: broken ceiling (top) and use of duct tapes to replace picture frames to minimize hazard during earthquakes.

SDN Tamanjaya 2 received renovation assistance and the construction of new library buildings from various private companies and humanitarian organizations. But the results of school renovations and the construction of new library buildings failed to refer to the Safe School Guidelines. This is evident from the class doors and library buildings that are still open inside and the absence of fire extinguishers in each room. Several damage in the ceiling also have not been repaired. However, several classes have minimized the use of heavy wall hangings and replaced with with duct tapes thereby reducing the threat of heavy objects when disaster strikes.
