INNOVATION OF SUBSTITUTE MATERIAL TO CONSERVATION EFFORT OF *Eusideroxylon zwageri* ON WOODEN BRIDGE MAINTENANCE PROJECT

Ita Minarni¹, Henry Wardhana², Aqli Mursadin³, Mufidah Asyari⁴

¹Postgraduated of Agricultural Doctoral Program, University of Lambung Mangkurat, Banjarbaru, South Kalimantan, Indonesia (ULM)

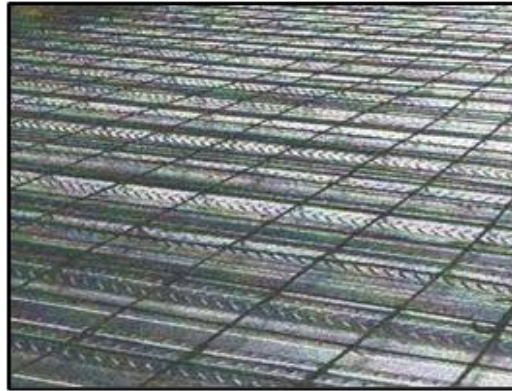
Figure 3. Installation of Reinforced Steel Composite and Floordeck

The Budget plan is prepared based on the calculation data of the volume of work obtained, the results of the calculation of the budget plan for the implementation of innovation work with a bridge size of 4 x 29.4 m is cost of IDR 200,000,000 (two hundred million rupiah) or USD 13,350 including all costs. Some part of the implementation of innovation by floor deck as shown in Figure 3. (Dias et al., 2016; Sahab et al., 2005).

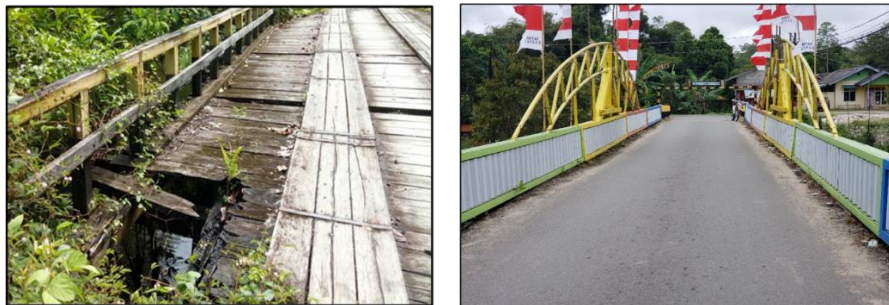
Figure 4. Bridge Condition Before and After Maintenance by Innovation

Planning and implementation analysis of the Tampa Bridge maintenance project was carried out based on the data obtained during the previous maintenance implementation. At the time of planning the maintenance of the bridge, there has been a change from the main material of ulin wooden bridge being replaced with a composite material of concrete and floordeck. The ulin wooden bridge, which had been broken for some time, could not be repaired (PUPR Buntok, 2018). In the end, the improvements could be made with the innovation of using floordeck composite materials and reinforced concrete then the Tampa Bridge can be used by the surrounding community as shown in Figure 4.

Investigation result of some technical data showed on safe level of self-load was 2,000.83 ton that higher than soil strength base was 1,250.52 ton. Noisy level was reduced 5.00 db when the composite floor bridge was lower previous wooded floor bridge compare the previous one. Deflection test result of all spans average 1.01 cm lower than the standard mention of 1.33 cm. The average concrete compressive strength result was 21.6 Mps higher than the standard 20.0 that the value can be accepted. Data of some technical investigation compare the previous wooden bridge by the innovation of composite of floordeck and concrete as mentioned in Table 1.

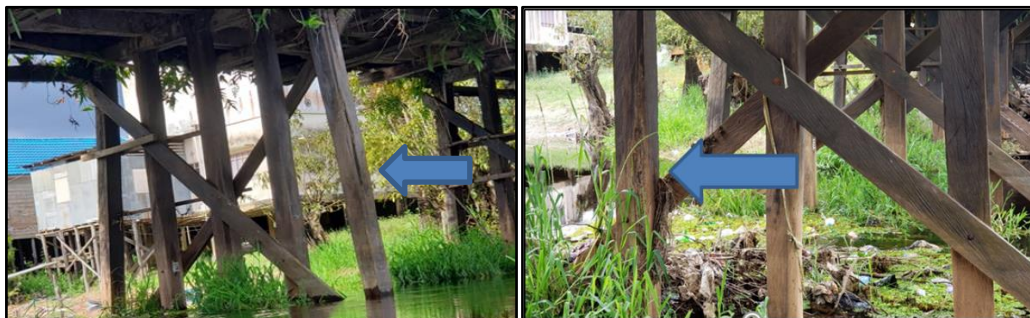
Figure 5. Tampa Bridge Condition during Investigation

Investigation on Tampa Bridge is based on field observations of the existing condition of the bridge. Area to be investigation are channels and water directions including riverbanks, embankments, and flood inundation areas, then the bottom of the bridge includes piers, fittings and sloop (Gal & Kryvoruk, 2010). For superstructure part includes the girders and floors, the results of investigation, the average importance the average service importance the results are presented in Table 2 and shown in Figure 5 and 6.

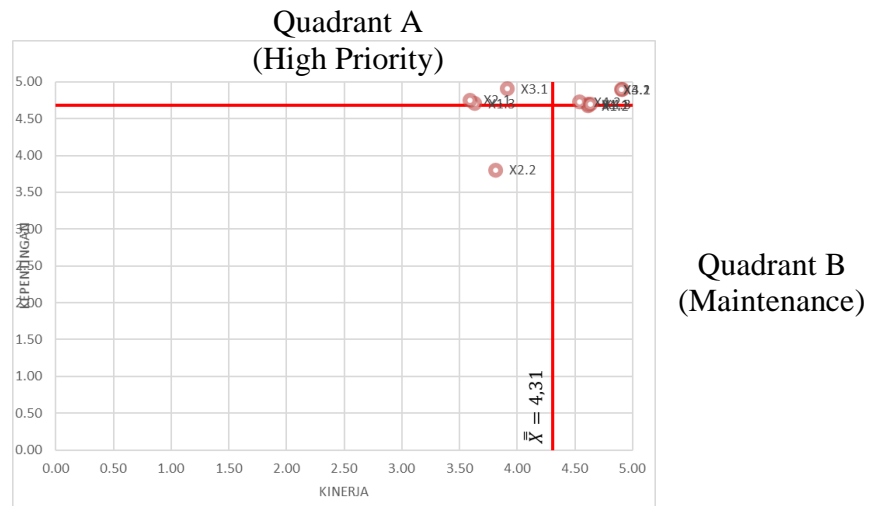
The summary of the investigation result shown in Figure 6, that the position of the data result in quadrant A means high priority to handle and some parts are in quadrant B means maintenance the existing those support better performance for the bridge itself and the user of the bridge.

Figure 6. Quadrant Summary Analysis of Bridge Performance and Users Satisfaction
