The contributions regarding to the behavior of bearings in wind turbines

Keywords— *wind turbine, bearing, stress, lubrication, simulation, defect, sustainable solution*

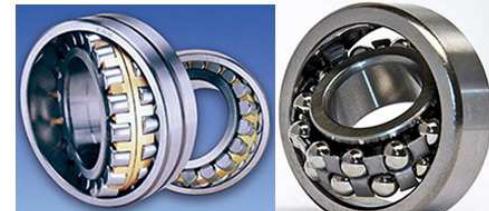
Fig. 8. Comparison between axial radial bearing with two-row tapered roller and axial oscillating roller bearing with two rows [14]

Since the rollers bear the greatest stresses during the operation of the turbine, compared to the ring or the cage, it is recommended that the material for them be better steel than the other elements (Fig. 8). Experimental research has shown that the use of such a double-row radial tapered roller thrust bearing, pre-stressed during assembly, reduces the axial load in the gear speed multiplier by 67% compared to the double-row tapered roller radial bearing [14], [19], [21], [25], [26].

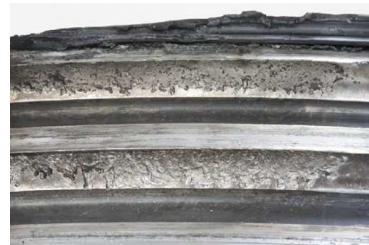
Fig. 18. Inner ring-exfoliation in the halves of the raceways

At the inner ring, exfoliation was observed in the halves of the raceways (Fig. 18) and weak points on the lower raceway (Fig. 19).

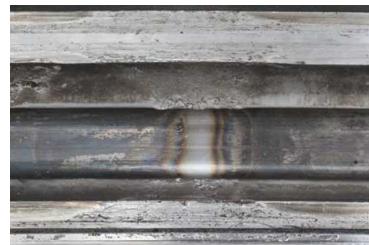
Fig. 19. Inner ring- weak points on the lower raceway
